THE PREDICTION OF STRUCTURAL FAILURES.

A thesis submitted to the University of
London for the degree of Doctor of Philosophy.

BY
PAUL SIBLY.

March . . 1977.

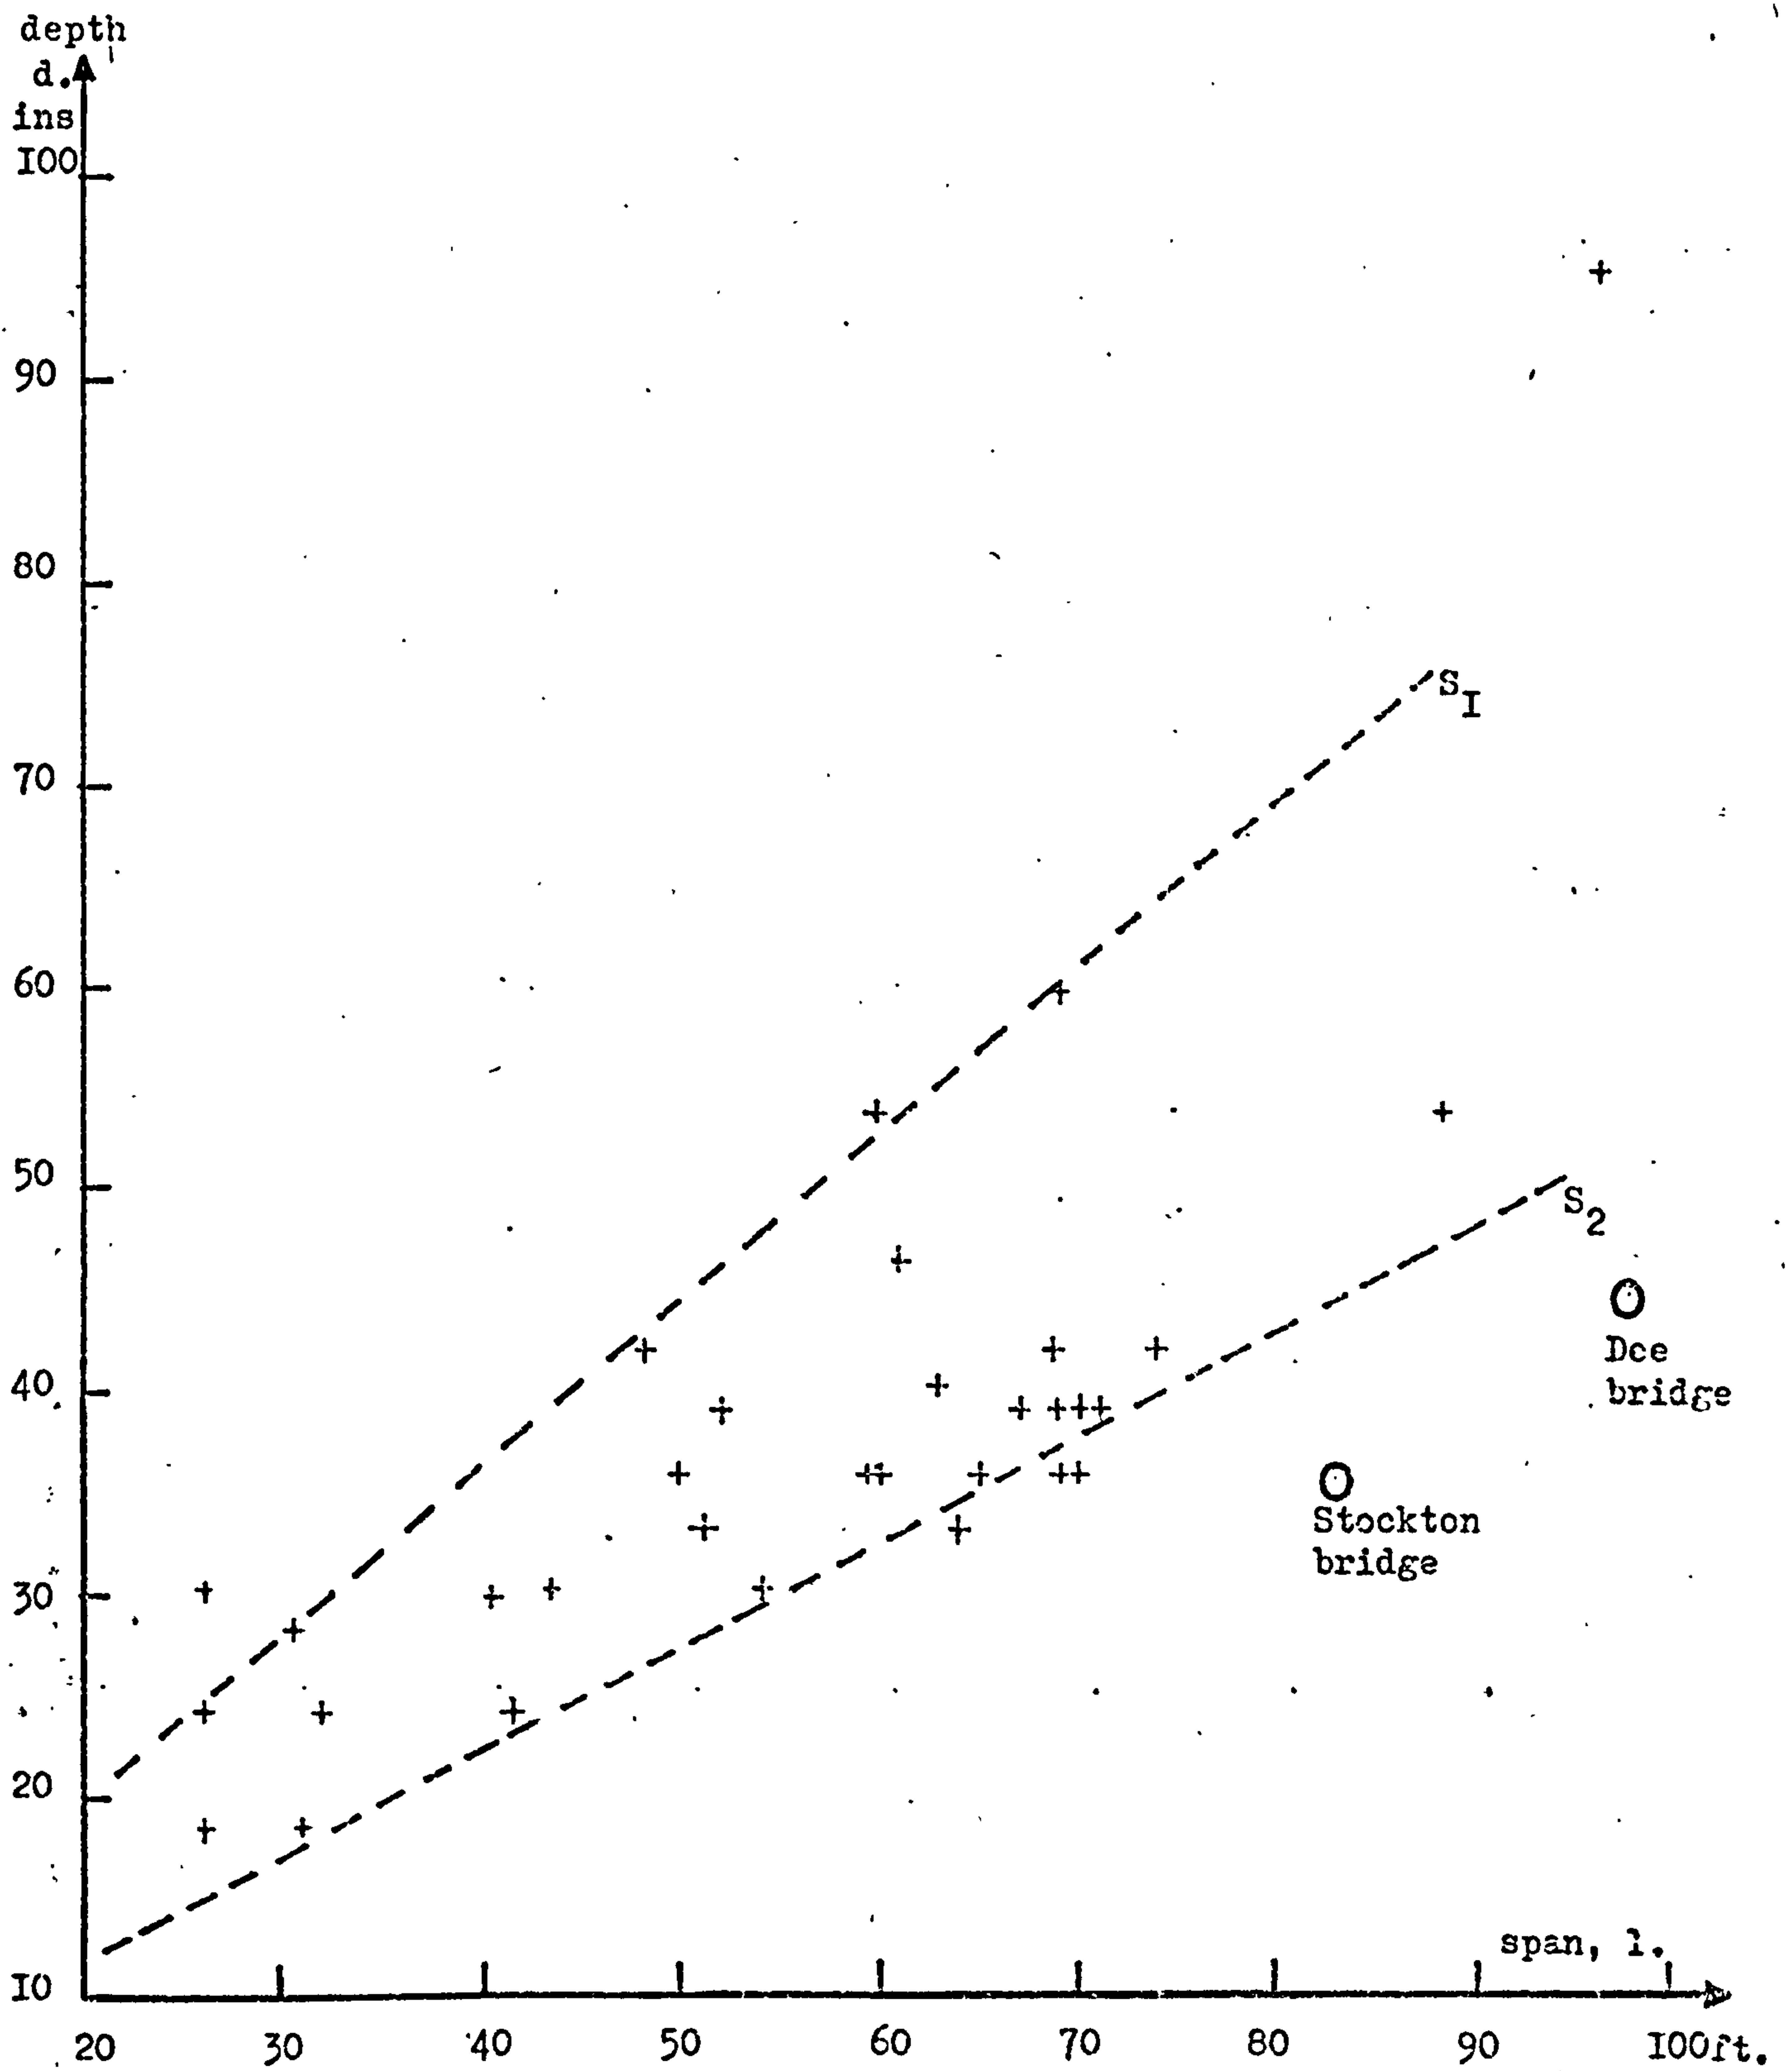
Fig 2.I6. Graph of depth of girder v. span, showing normal limits of practice (S_1 and S_2).

This outline of the Dee Bridge would not be complete if attention was not drawn to the fact that the structure was unusually daring, not only because its span was longer than any earlier examples but because the other geometric parameters were devised so that both cast and wrought iron were used exceedingly sparingly. From Table 2.2 and fig.2.16 it can be seen that the girders were unusually shallow and that the section of the top flange was not increased to sustain the additional compression thrown upon it by the prestressing.

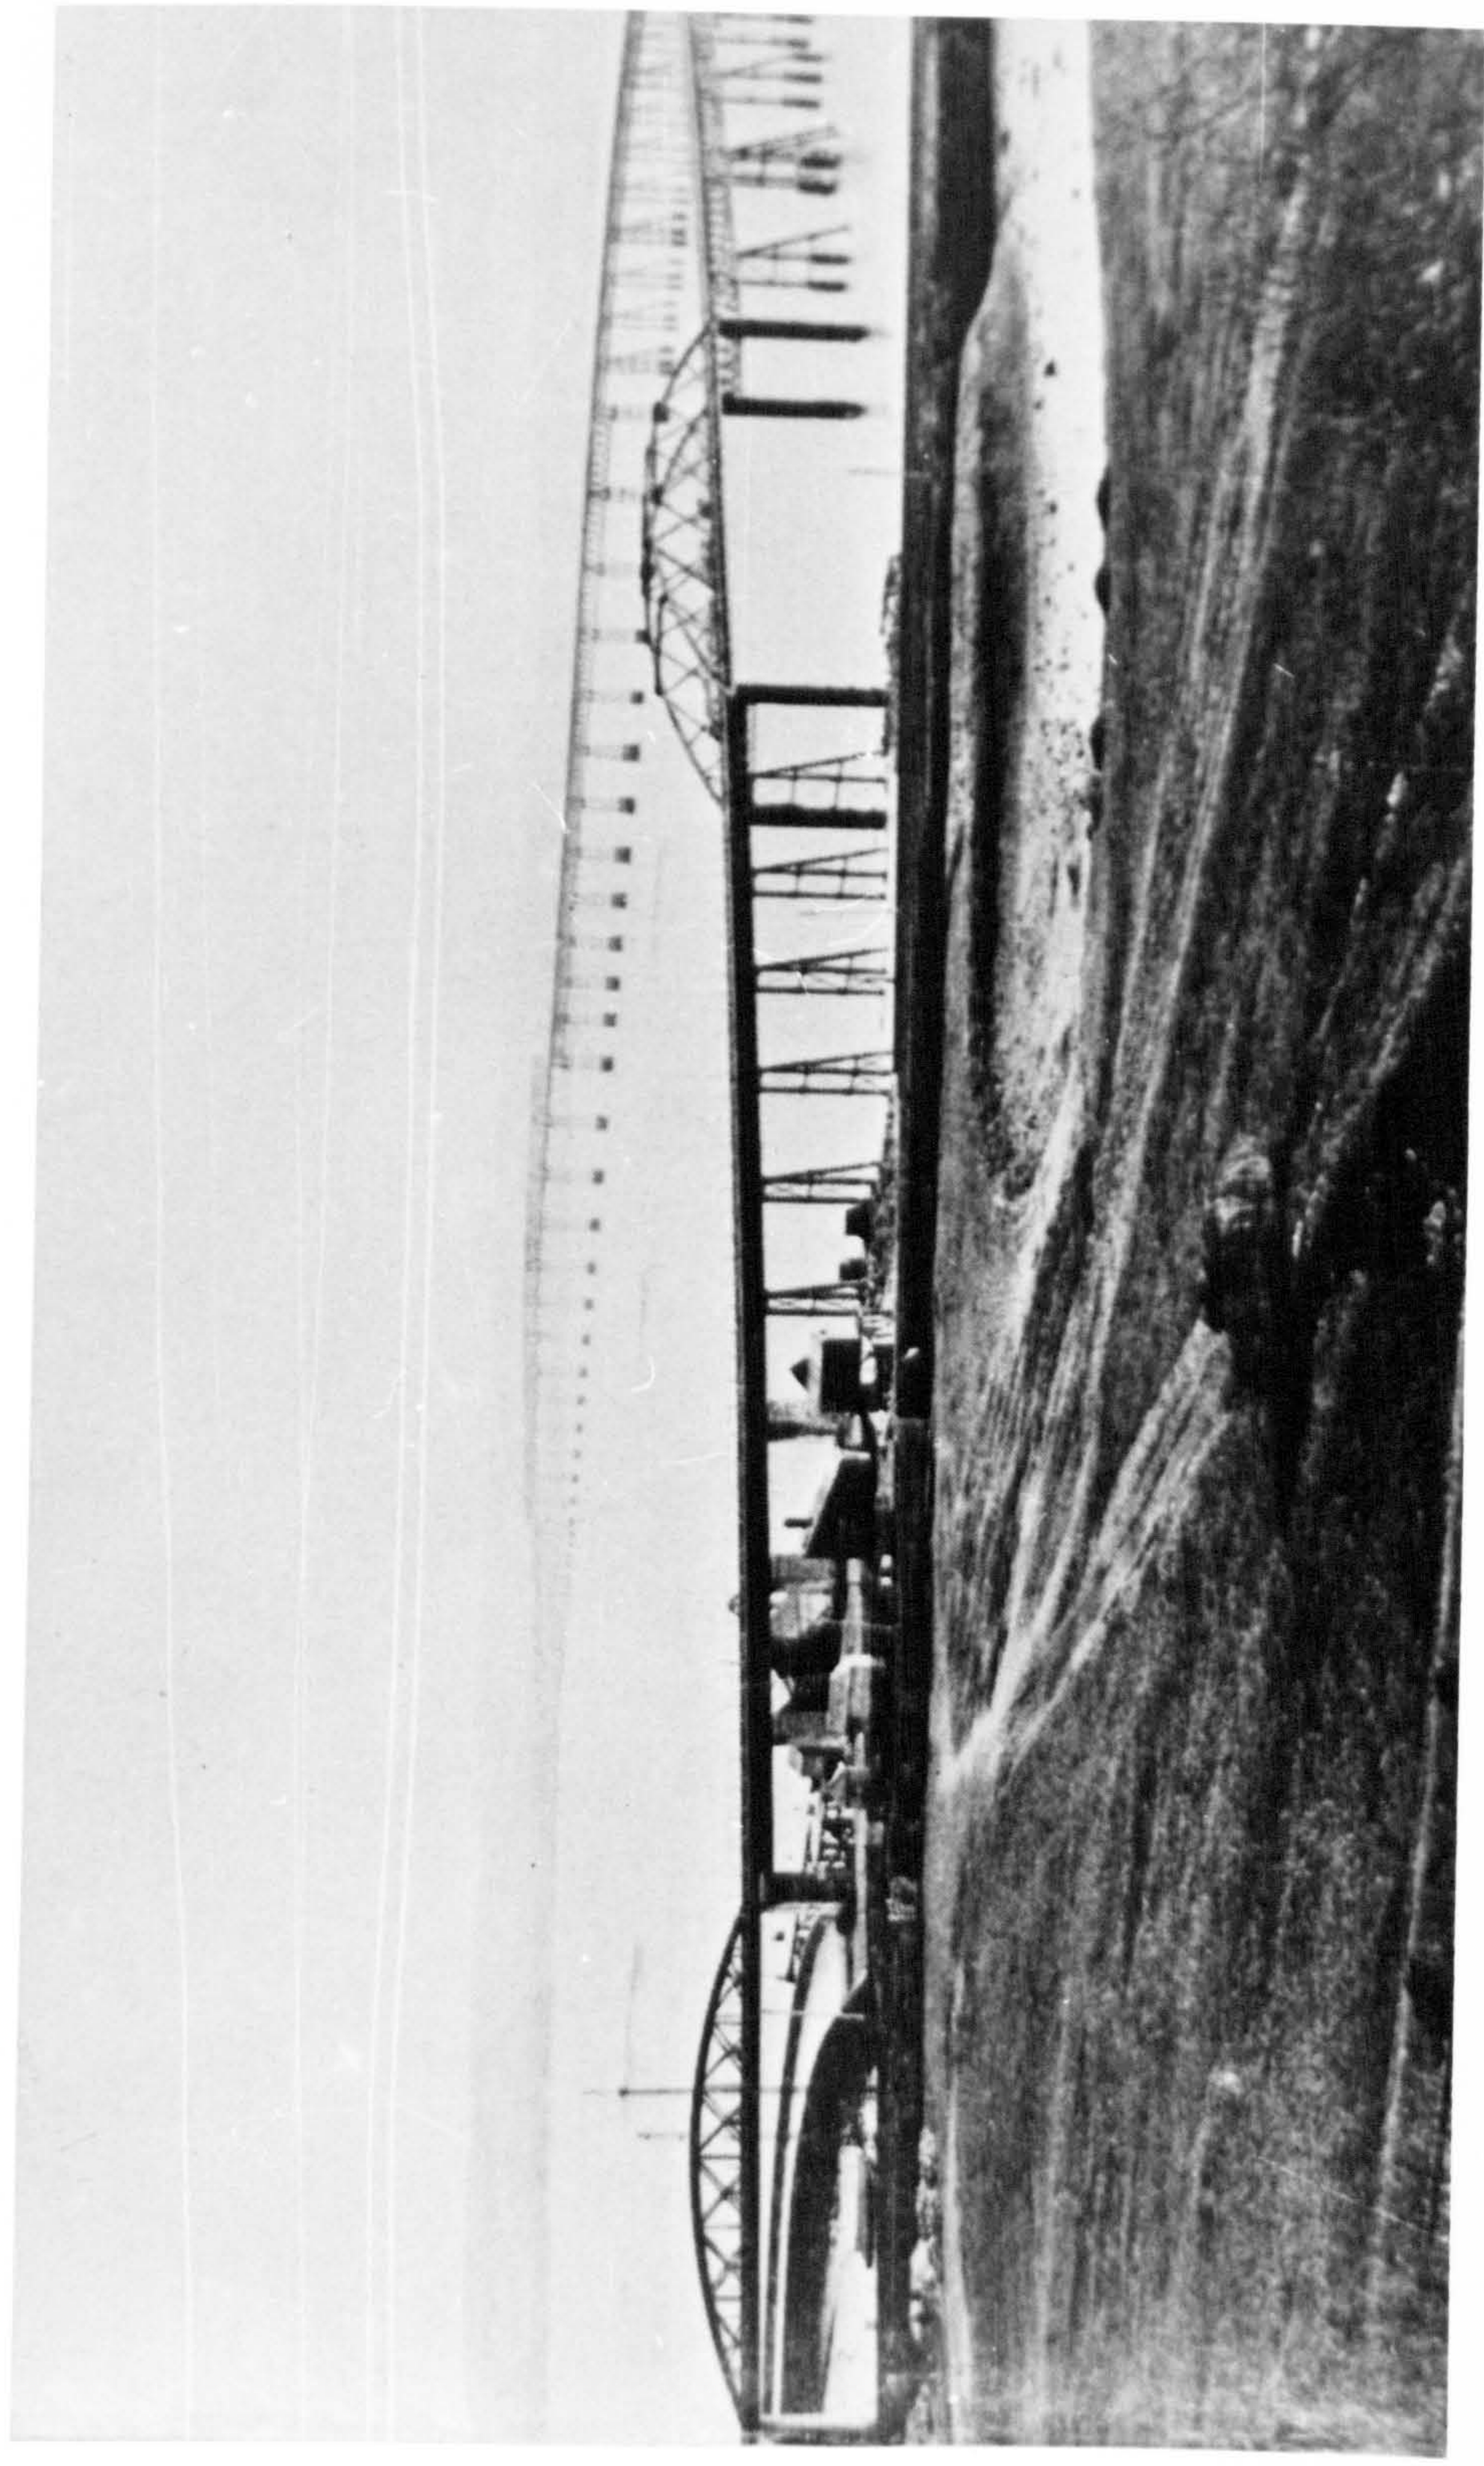
Fig 3.I. The first Tay railway bridge, seen from the north.

The bridge in question was the first really long high-level crossing of a storm lashed estuary (fig.3.1). The single track main line of the North British Railway was carried on a wrought iron superstructure 3.2 km long which reached a maximum height of 27 m above the water. There were 85 truss spans varying in length from 8 to 75 m; depth/span ratio was about $\frac{1}{8}$ and the width 3.8 m. The piers were of various types but groups of cast iron columns crudely braced with wrought iron predominated. Below water level these were carried down to the estuary floor via a masonry substructure. The total cost was £350,000 compared with £217,000 estimated in 1871 just before construction began.

For example, although rock was believed to exist just below the sand layer on the estuary floor, it was soon found that the seemingly solid material was nothing more than a thin crust of conglomerates covering an indeterminate depth of mud and clay. This led to a decision to reduce the weight of the structure by abandoning the masonry towers originally intended in favour of cast/wrought iron substitutes. However, the underwater part of the piers was not altered, so the iron-work had to make do with the very restricted base area available. This gave the bridge a rather top heavy appearance. (fig.3.1).

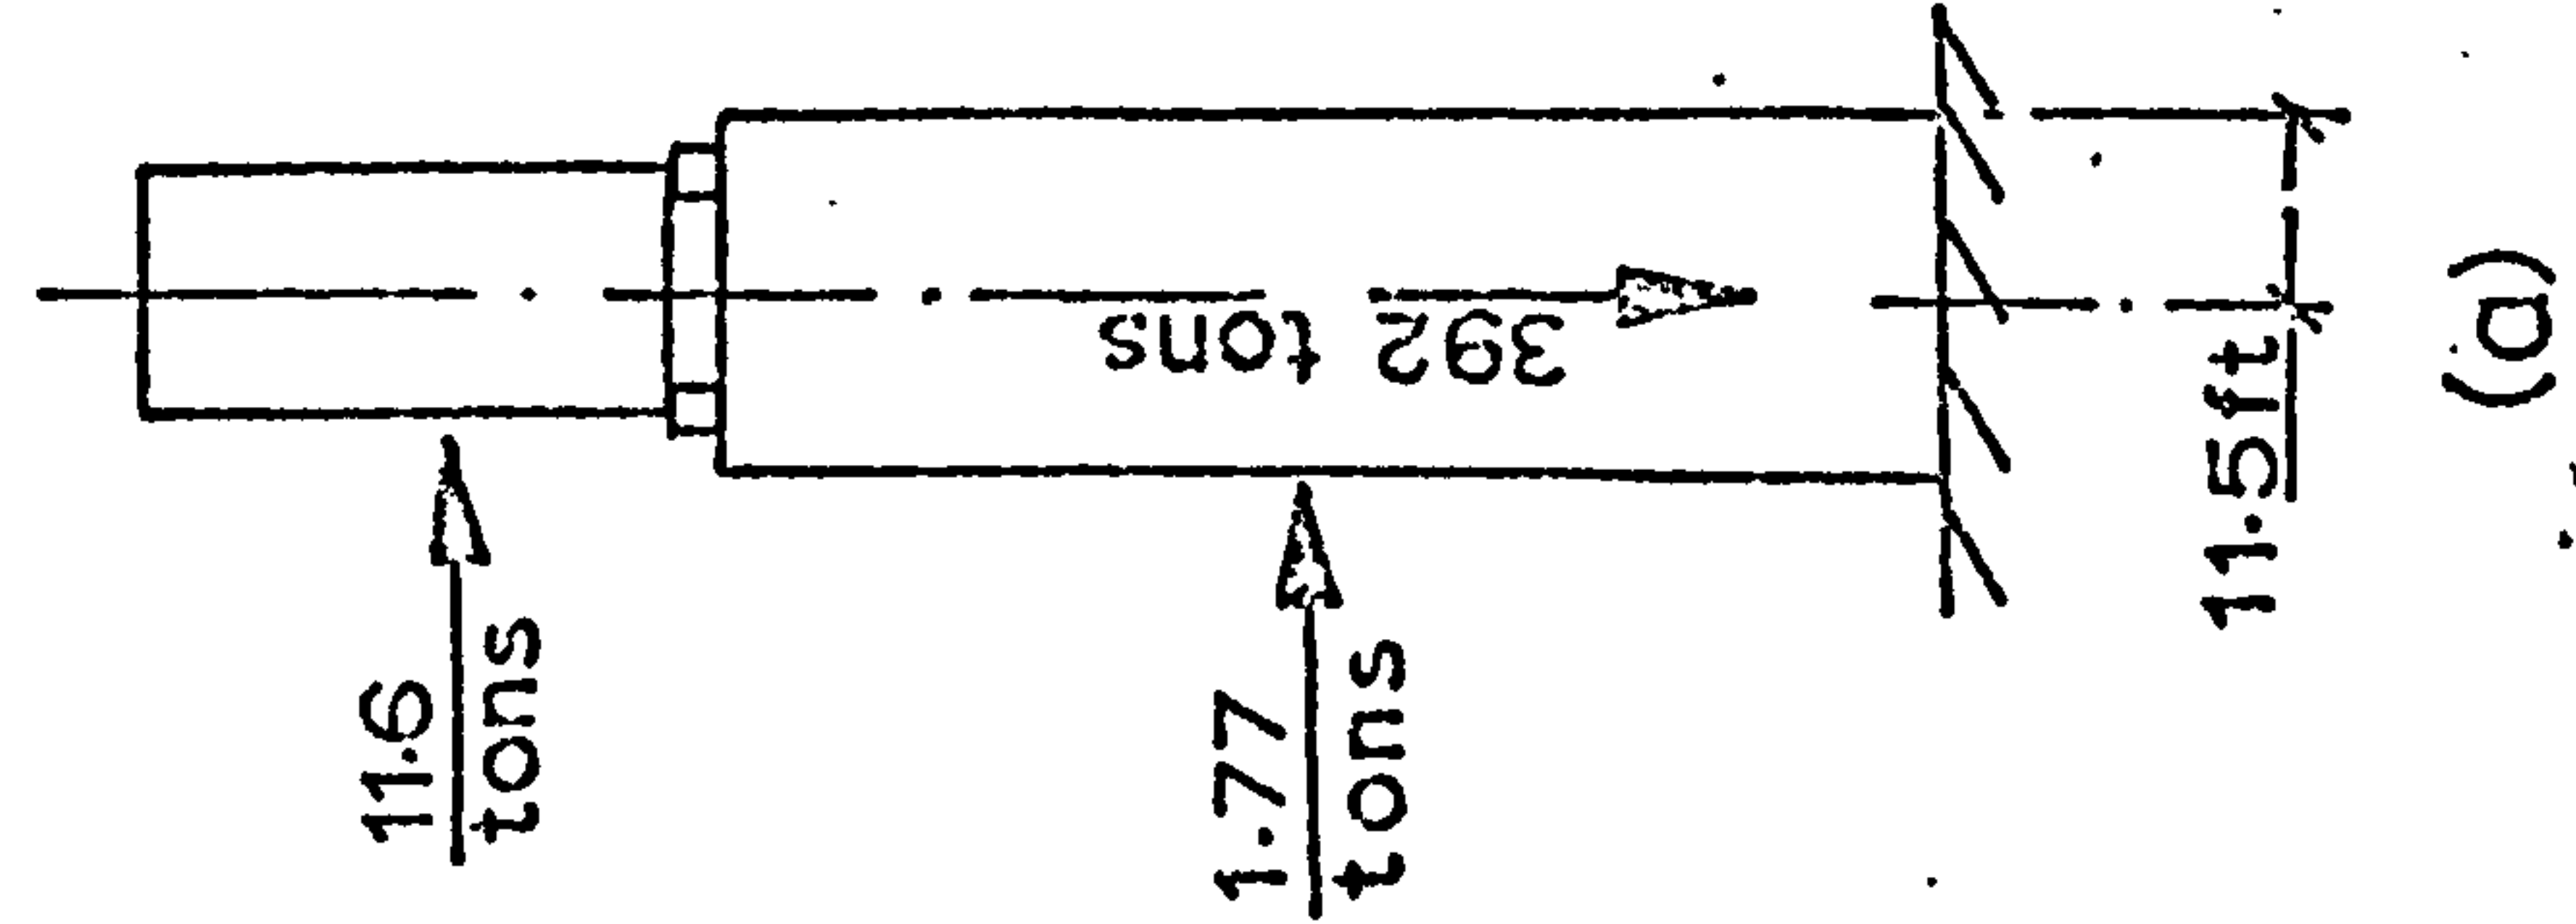
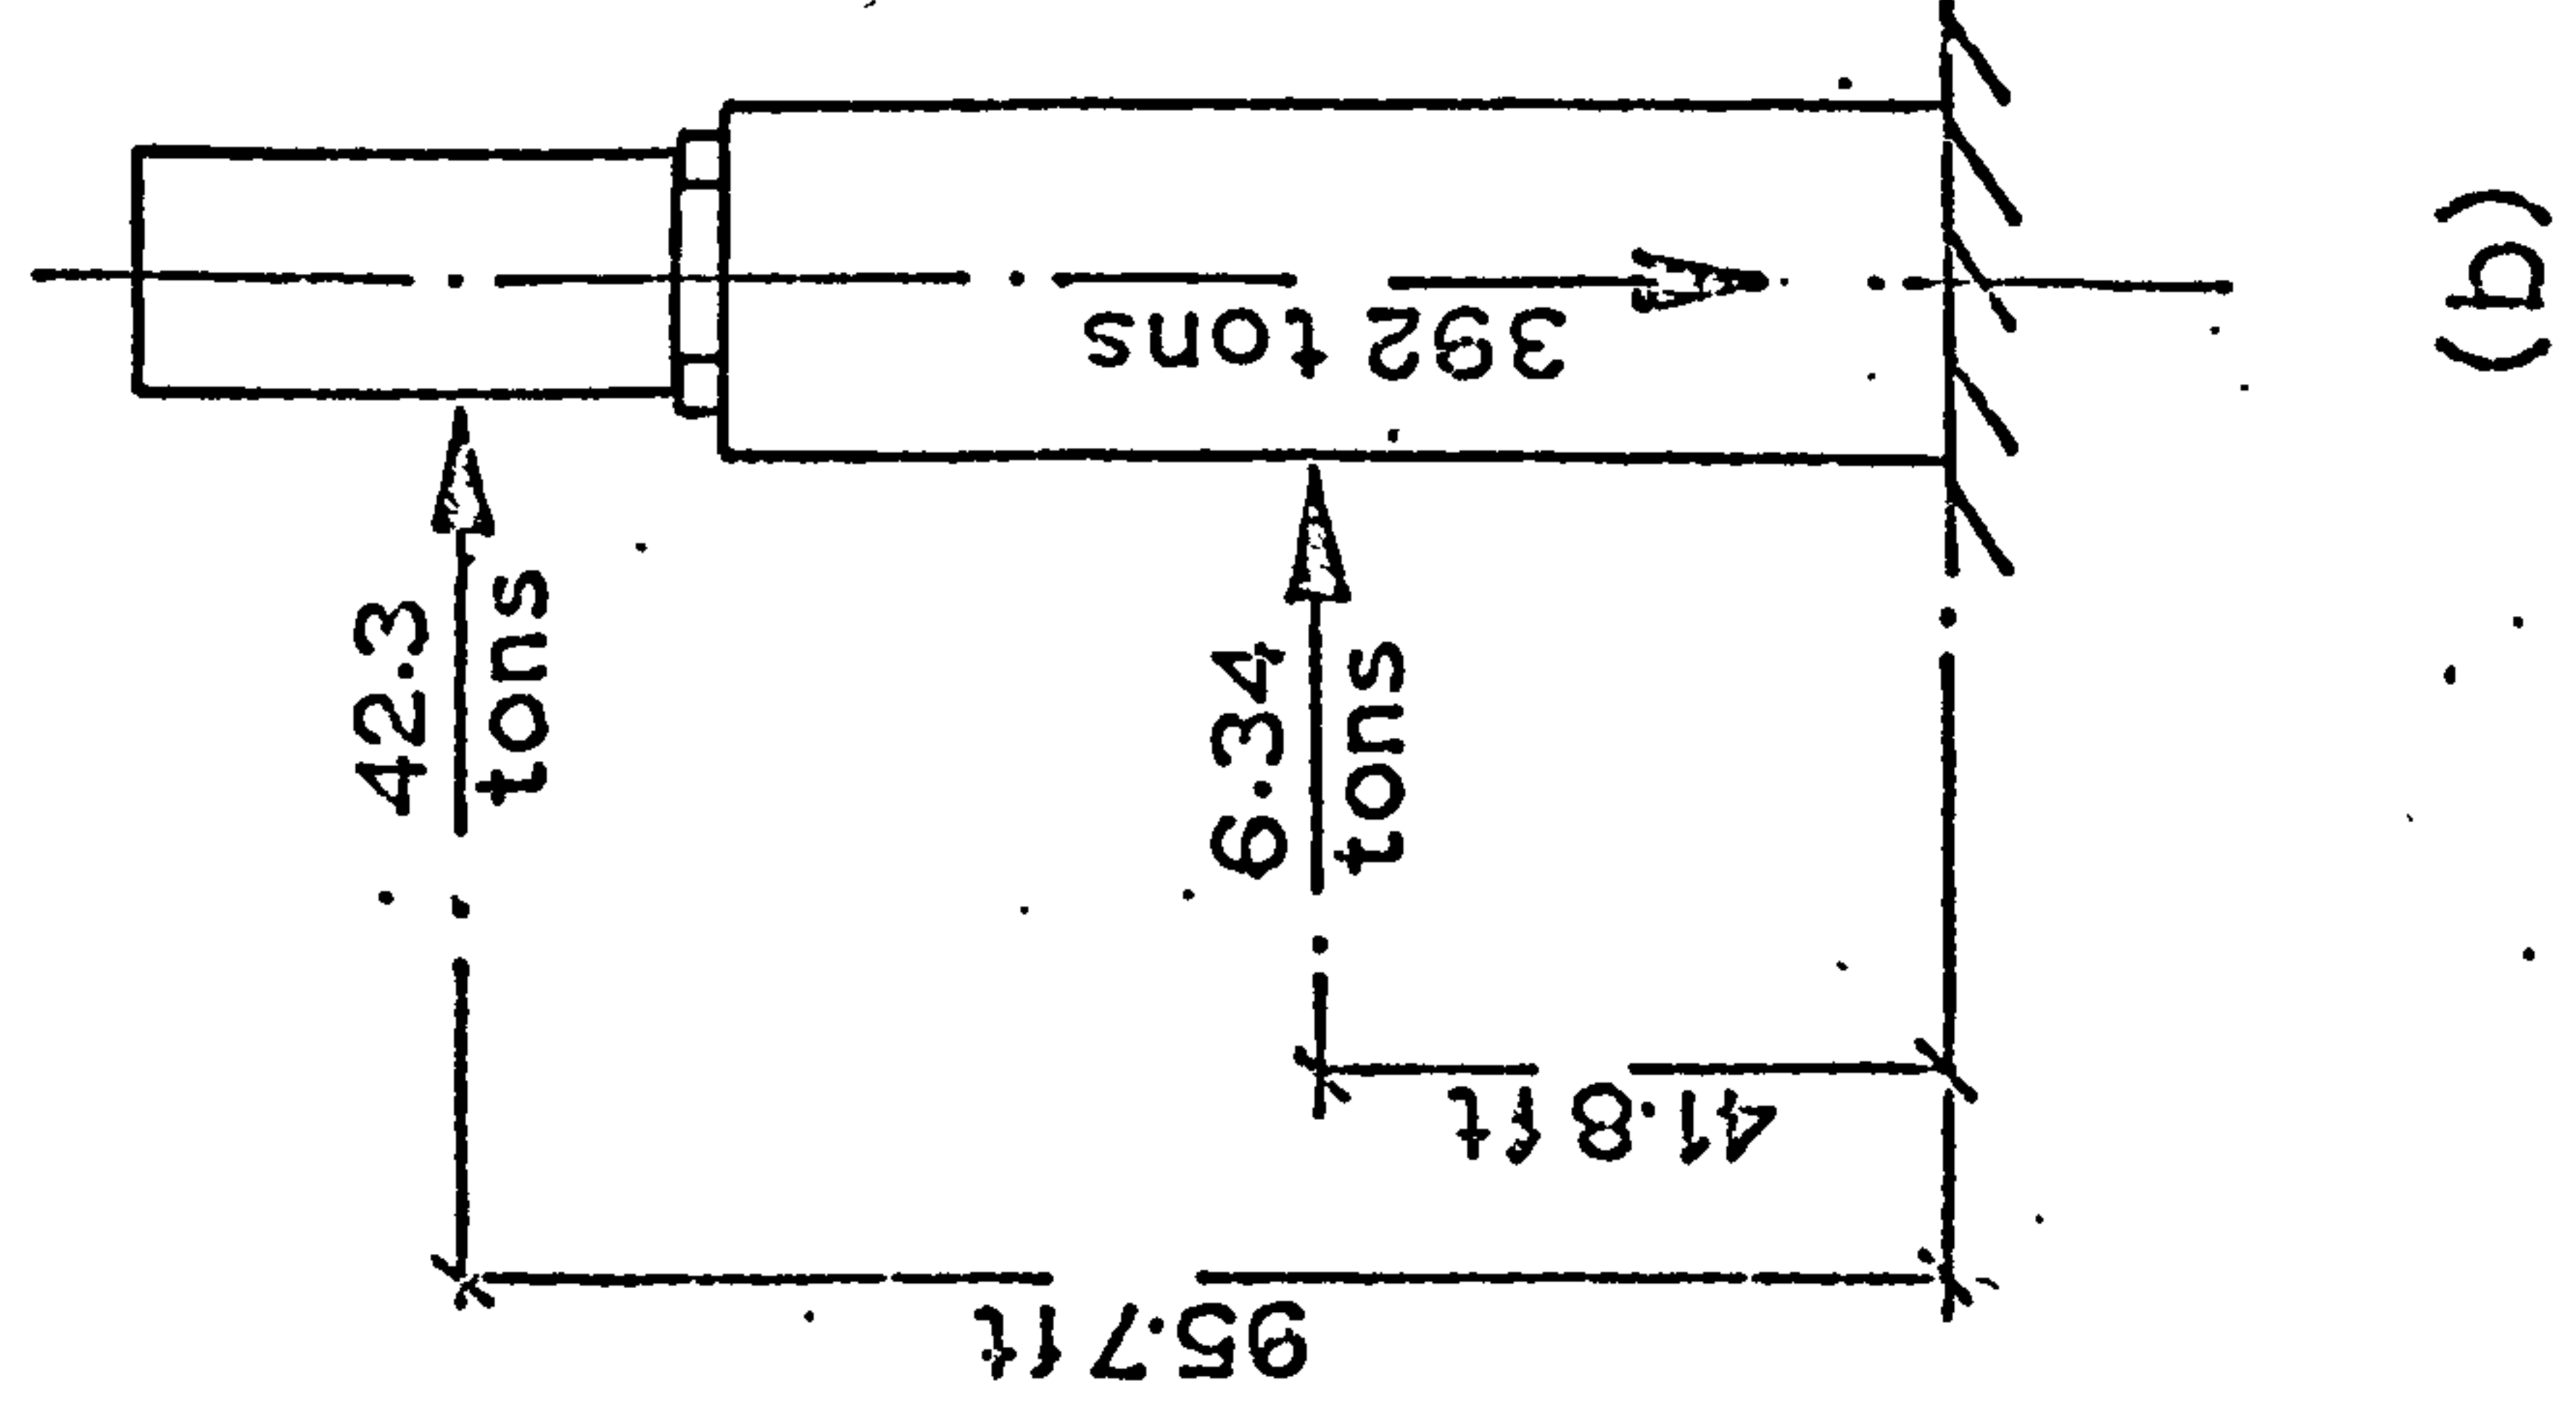
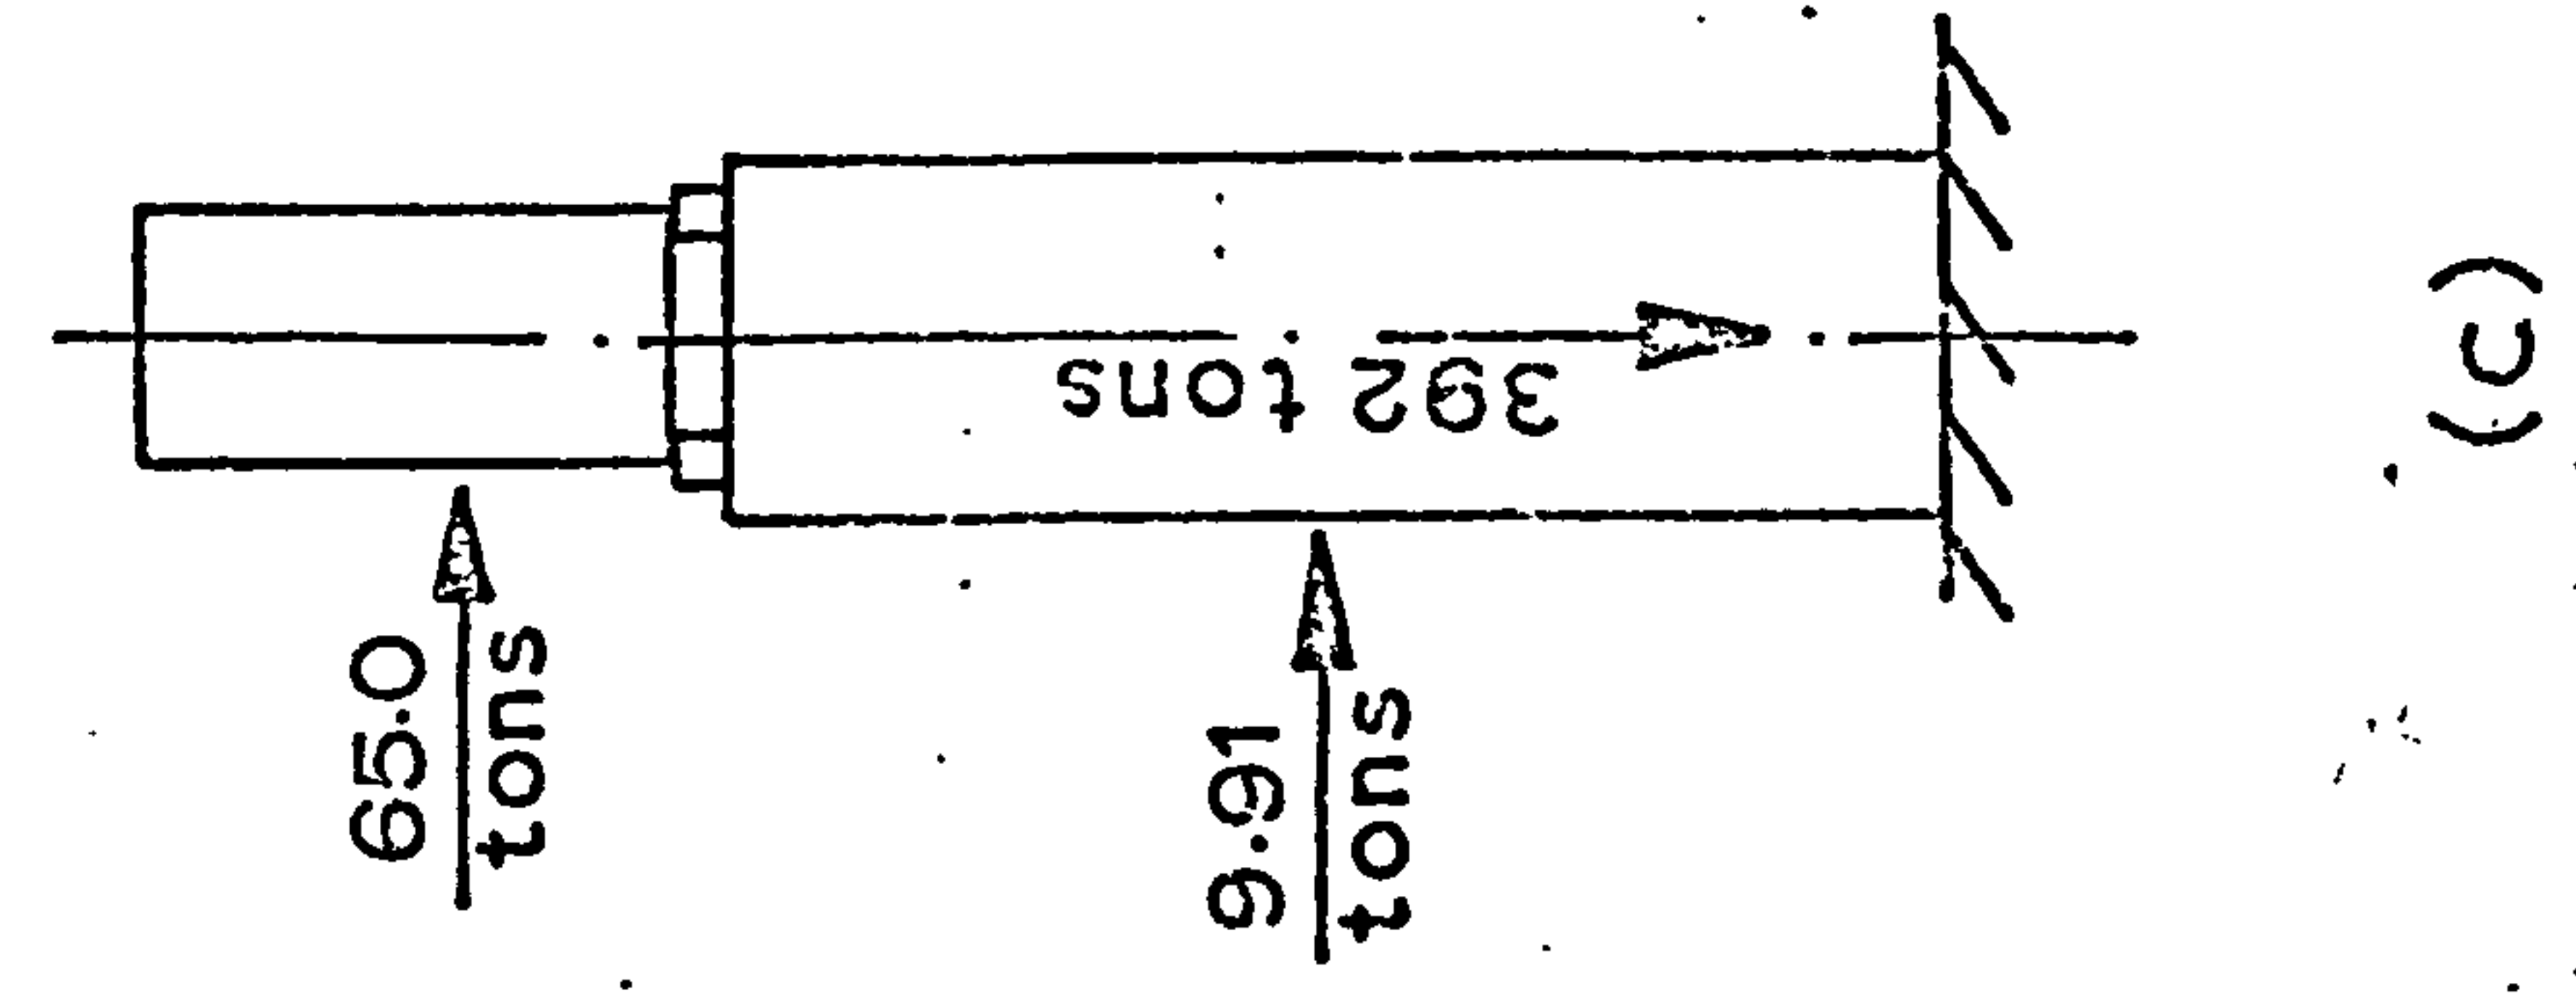
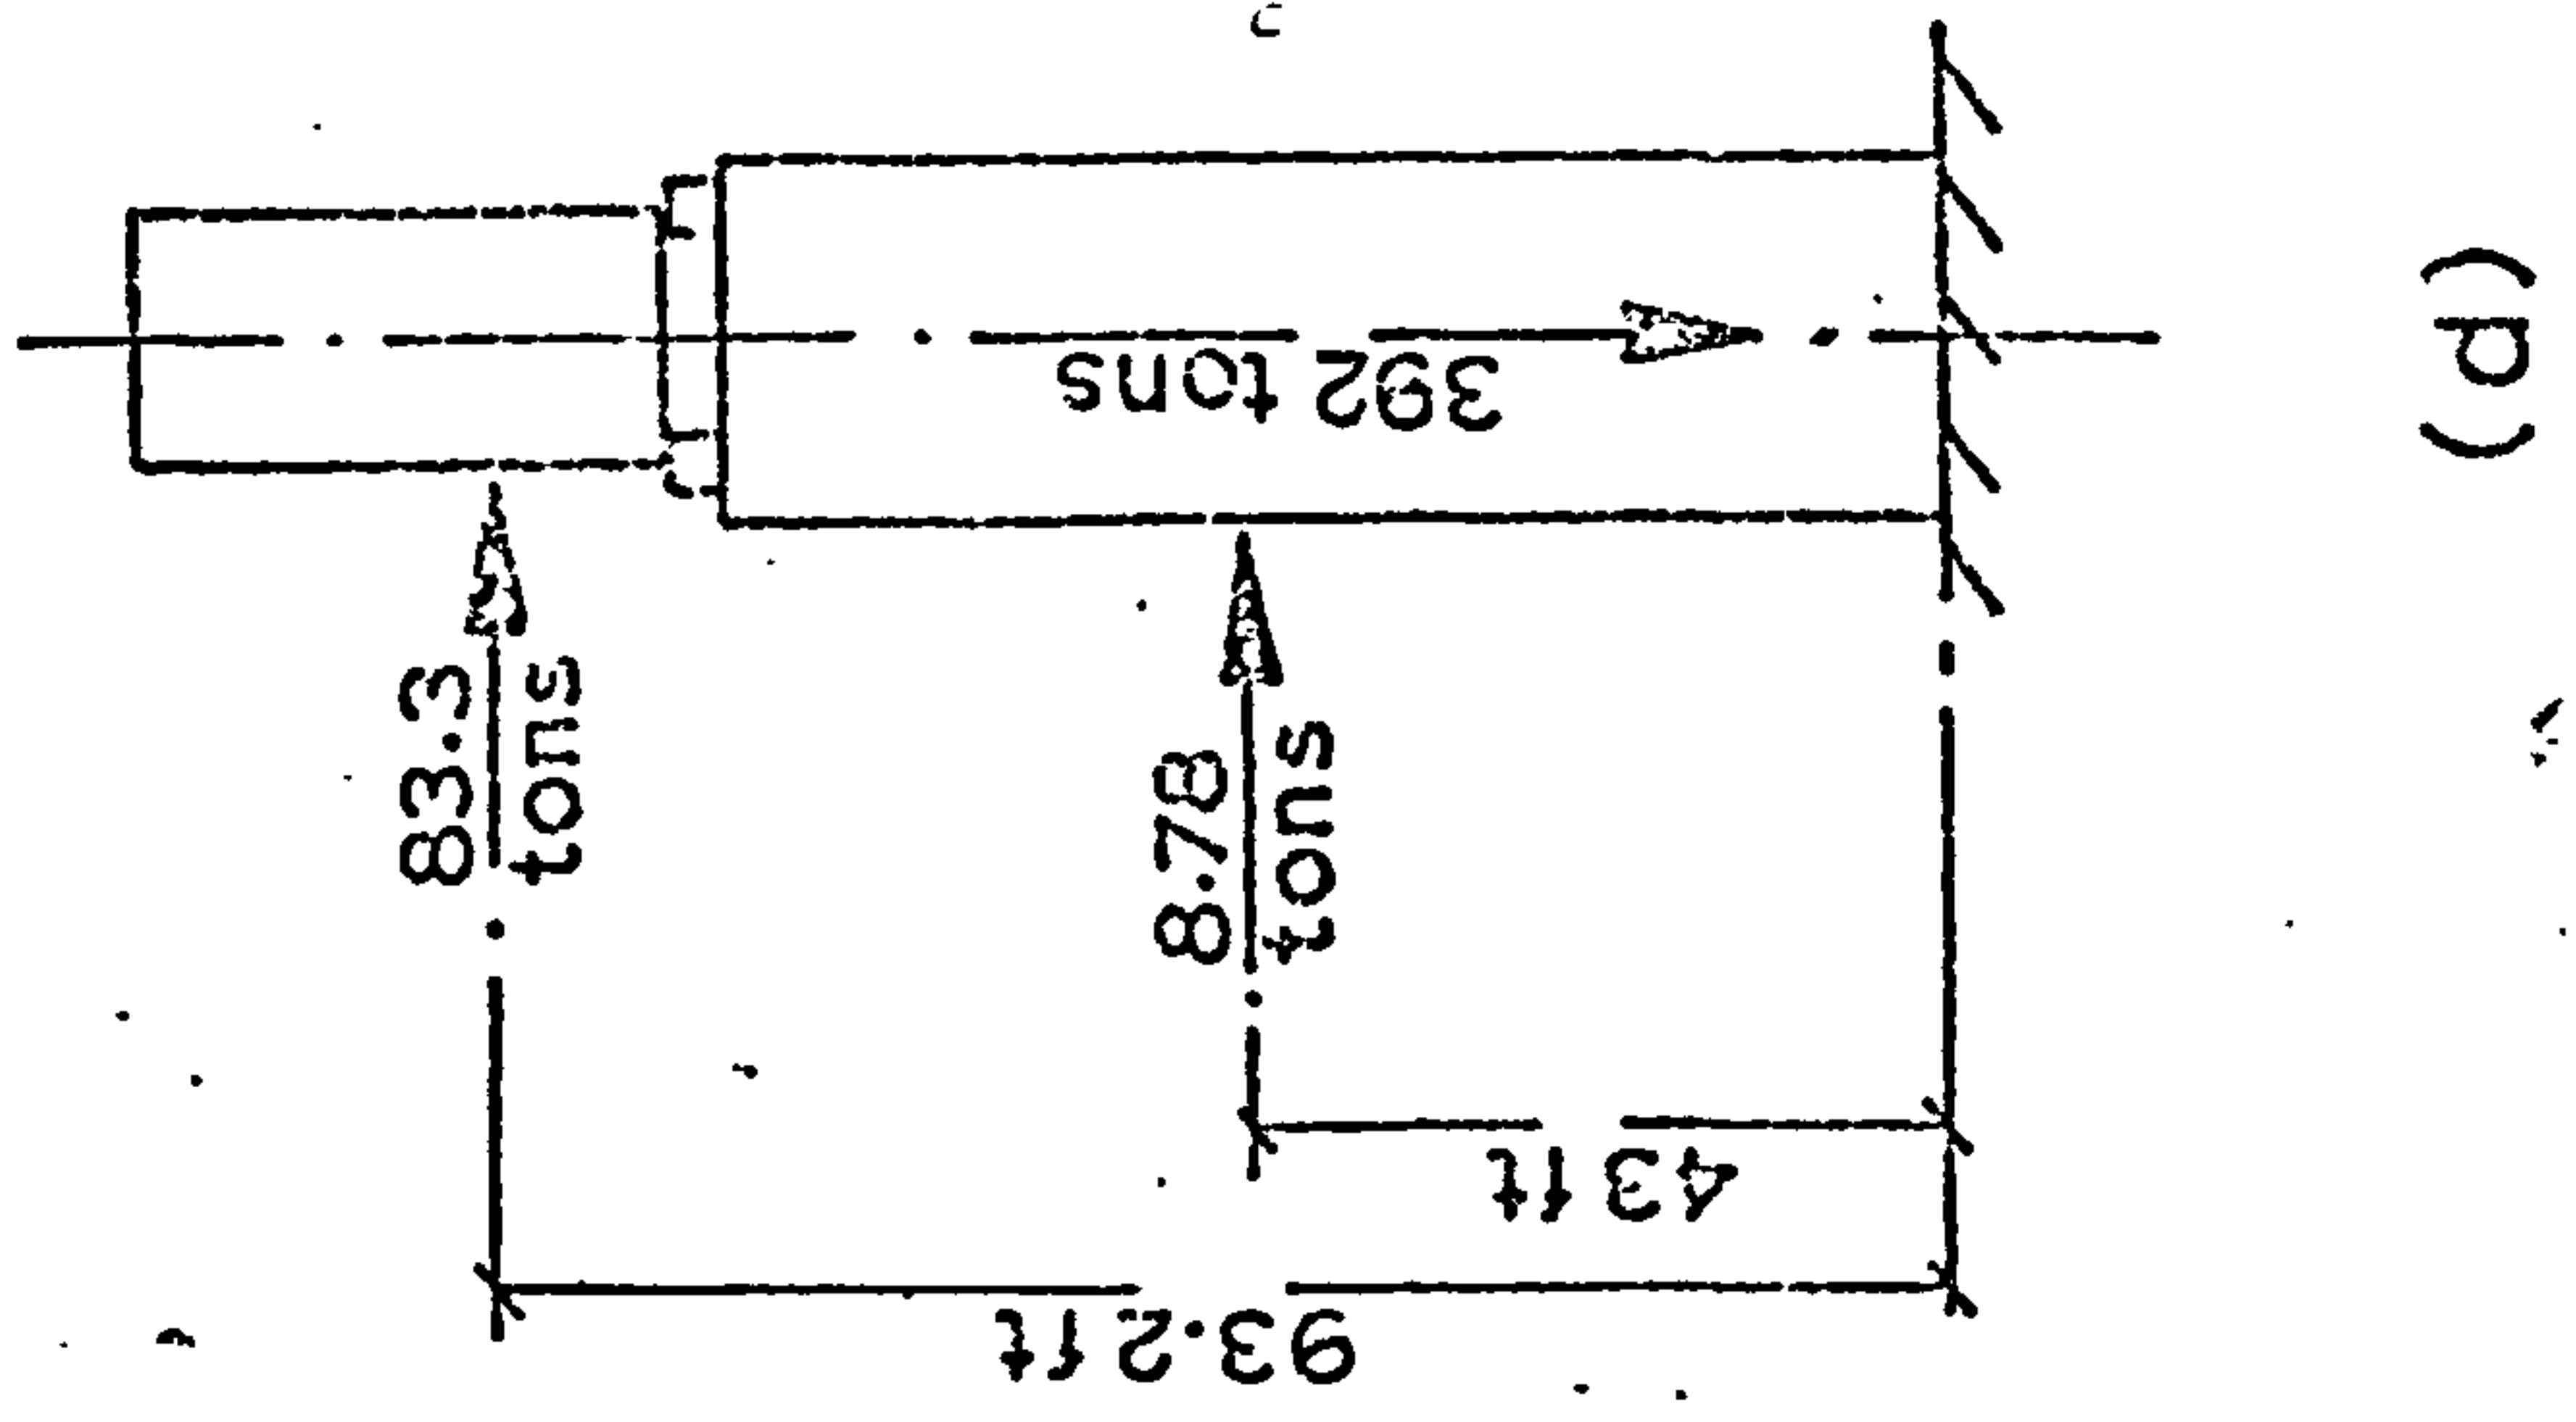
Fig 3.2. Wind forces as calculated by four different methods.

When a design check was made for wind action the procedure adopted was to assume that a uniform pressure of wind acted on the exposed face of the bridge and that some fraction of this acted on the lee girders. The precise amount depended on an intuitive guess of the degree of shielding afforded by the windward members - an unsatisfactory procedure because designers did not understand effects such as drag and lift forces. To show how seriously wind forces were underestimated, fig.3.2 compares four loading cases. Fig. 3.2a is based on the wind pressure assumed in design - 485 N/m^2 (10 lbs/ft²). 3.2b shows the forces necessary to overturn the structure about the base of the lee pier. This calculation was made by Mr Henry Law who was commissioned by the Tay Bridge Inquiry to analyse the structure after the collapse. From the evidence of the wreckage, he showed that the windward columns were inadequately anchored to the pierheads, so he discounted the possibility of beam action in the towers. He also showed that this mode of failure was more likely than the overturning of the spans on the tops of the towers.³

Fig.3.2c shows the wind forces suggested by the Board of Trade rule which was established after the collapse. Although this was ridiculed as extremely conservative by engineers at the time, it is interesting to note that the total force and overturning moment generated by it is very considerably less than the corresponding quantities calculated from the 1972 wind loading code, CP3, ch.5 part 2 (fig. 3.2d).⁴
